TEXAS OFFICIAL WOOD DESTROYING INSECT REPORT

1234 Sunshine Road,
INSPECTED ADDRESS

3. Really Soon

5. Main House Only

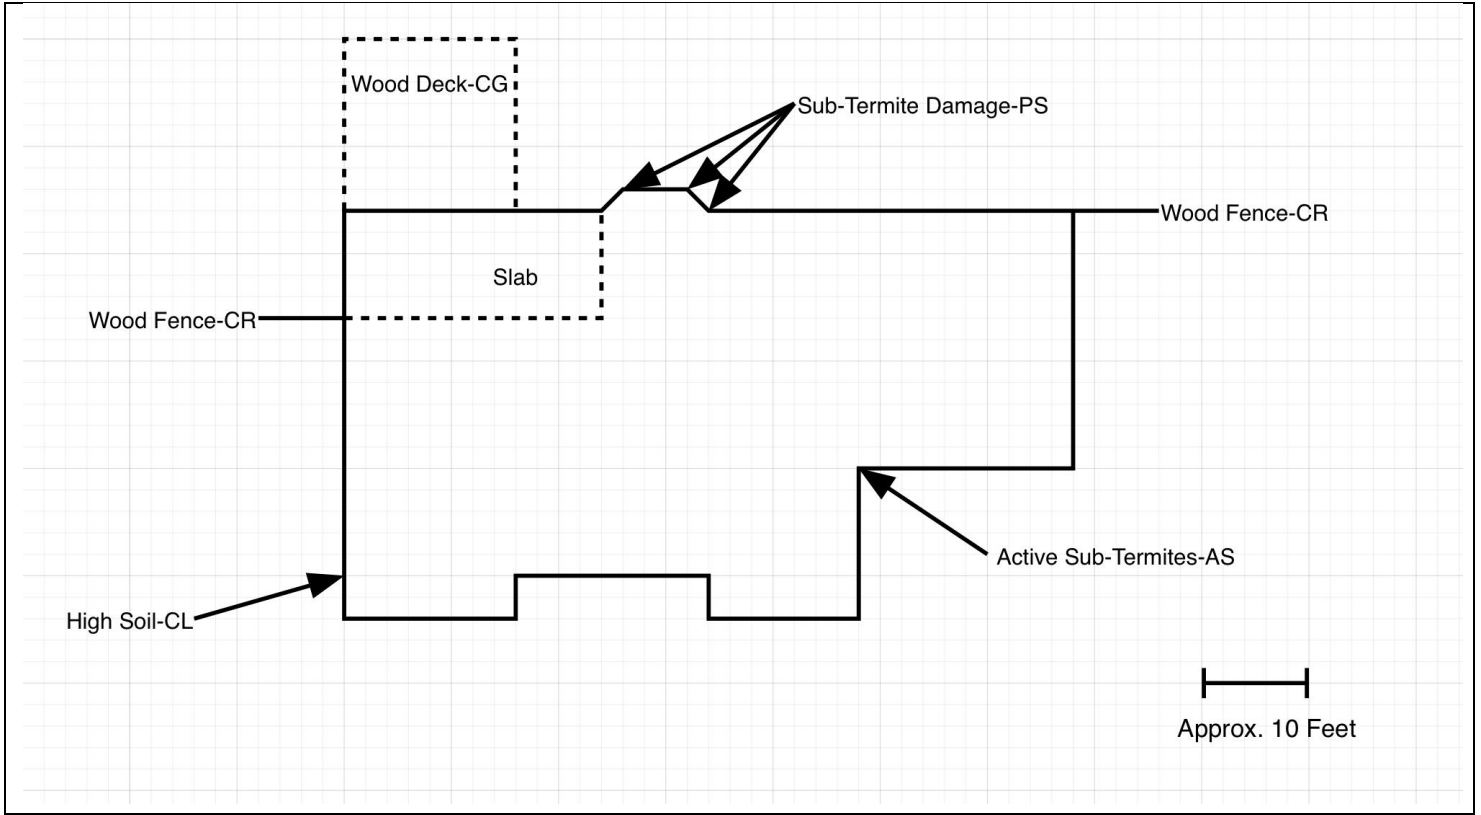
8G. Visible evidence of: active sub-termites/previous sub-termites

has been observed in the following areas: front between the two garage doors/rear around the bay window

The inspector must draw a diagram including approximate perimeter measurements and indicate active or previous infestation and type of insect by the following codes: **E**-Evidence of Infestation: **A** (active), **P** (previous); **D**-Drywood Termite; **S**-Subterranean Termite; **F**-Formosan termite; **C**-Conducive Conditions; **B**- Wood boring Beetles; **H**-Carpenter Ants; Other(s): _____

Active sub-termites were noted at the front between the two garage doors and previous sub-termite damage was noted at the rear bay window. Recommend treatment in accordance with TDA standards.

9A. Corrective treatment recommended for active infestation or evidence of previous infestation with no prior treatment as identified in Section 8. (Refer to Part G, H, and I, Scope of inspection) Yes [X] No []
