PROPERTY INSPECTION REPORT

Concerning: 1234 Sunshine Street
(Address of Inspected Property)

Pleasantville, TX 76111
(City, State, Zip)

September 19, 2009
(Date)

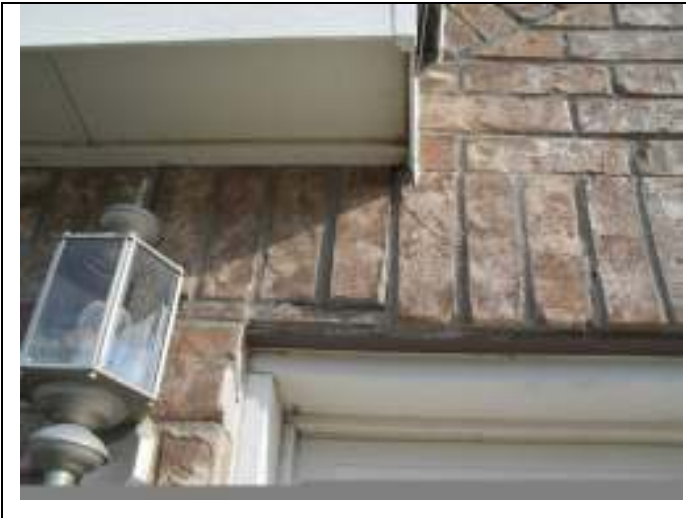
1. The foundation has shifted in one or two areas evident mainly by a couple of exterior brickwork cracks, including a crack above on the overhead garage doors and a few interior sheetrock cracks. The laundry room door does not latch properly. There is poor drainage in some areas around the perimeter of the foundation, mainly along the garage side and the rear of the house. Recommend this be corrected to help minimize future foundation movement. However, I do not believe foundation repairs are warranted at this time. Proper maintenance should be maintained to minimize foundation movement.

Sample of exterior brickwork crack

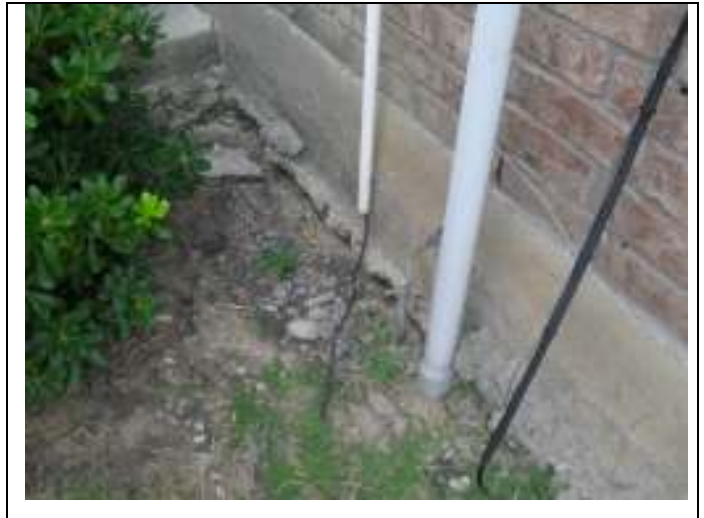
1. The sprinkler control wire on the garage side of the house is exposed and unprotected.
2. Zones three and six of the sprinkler system did not respond when tested.

Exposed sprinkler control wire on garage side

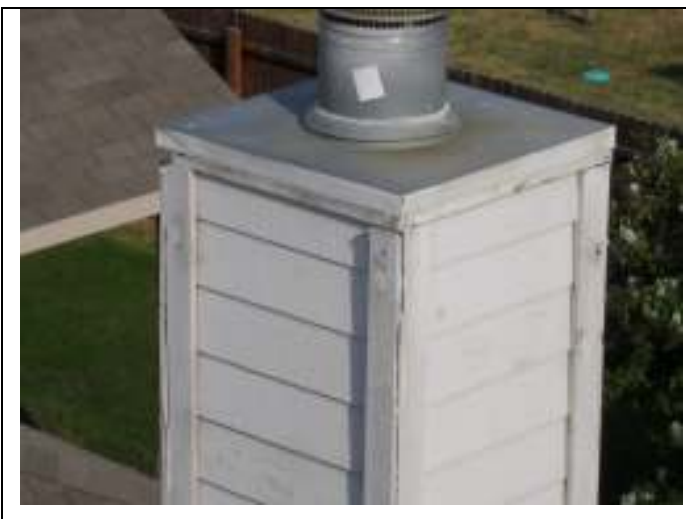
4. The trim on the chimney is damaged. The paint on the trim is peeling and the trim is separating from the chimney. Unable to determine the condition of the underlying materials.

Sample of damaged and separated trim at chimney
